**FUTURE FISHERIES IMPROVEMENT PROGRAM GRANT APPLICATION***All sections must be addressed, or the application will be considered invalid*

- A. Project Name: Spillway Pipe Replacement & Dam Head Cut Repairs - Haughian Bass Reservoir
- River, stream, or lake: Haughian Bass Reservoir
- Location: Township: 12N Range: 48E Section: 9
- Latitude: 46.81708 Longitude: -105.68968 *within project (decimal degrees)*
- County: Custer
- B. Purpose of Project:

Rehabilitation Project - Haughian Bass Reservoir

Prepared by Mike Backes – Region 7 Fisheries Manager

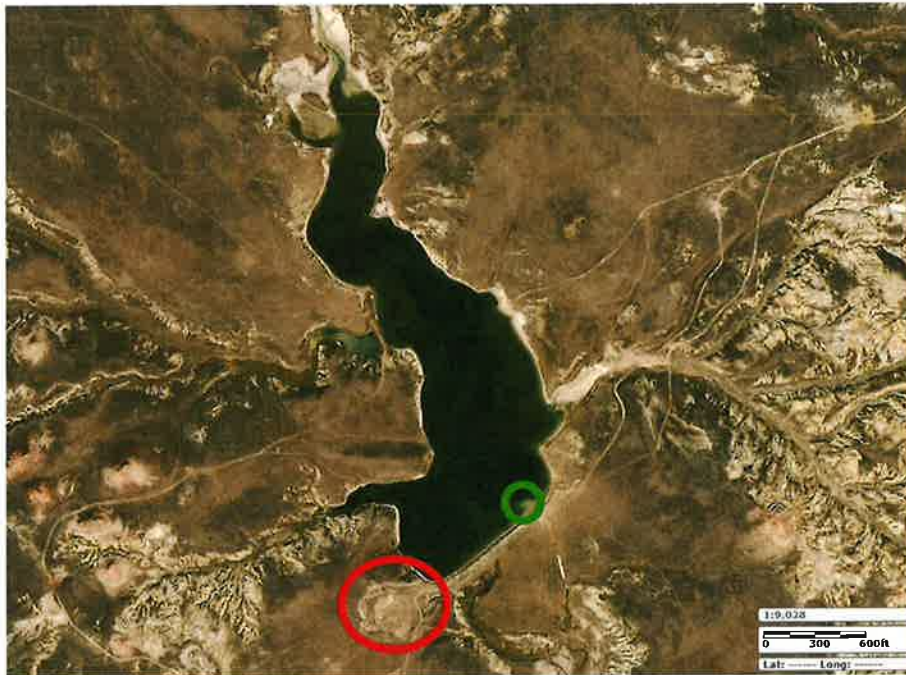
Figure 2 Satellite image of Haughian Bass Reservoir; green circle damaged spillway pipe; red circle head cut location.

Project Need: shifting ice damaged the existing spillway tube and concrete foundation in March 2019 (Figure 2 & Picture 1). The landowner and FWP placed sandbags around the damaged pipe to reduce water loss and minimize additional damage from current water levels. Failure to repair the pipe could compromise the spillway over time and loss of 3-4 feet of water depth increases the risk of winter killing the fish population.

A secondary concern is a large head cut that is expanding on the west end of the dam (Figure 2 & Picture 2). Run off over the local landscape is expanding the depth and length of the head cut. Continued growth (depth and length) could compromise the integrity of the dam.

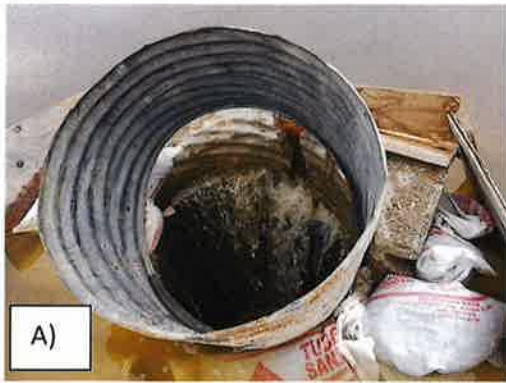
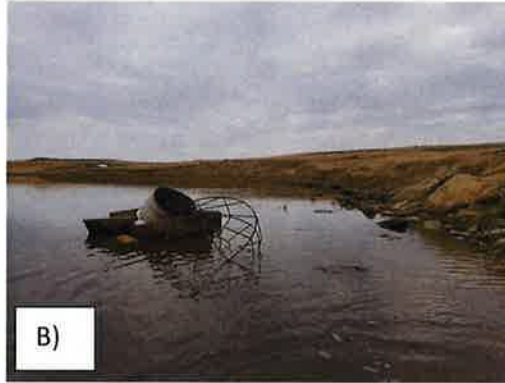
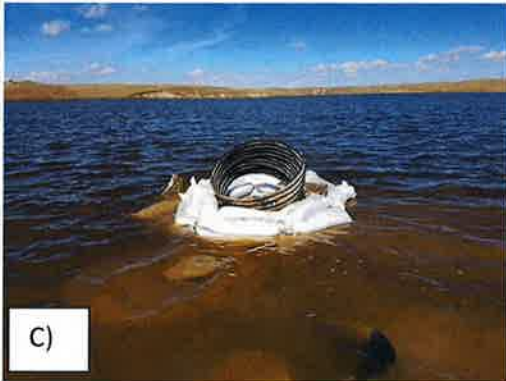
Spring runoff in 2019 was early and quick. The rising water level floated and released the mostly intact ice sheet from the ponds shoreline. A substantial wind followed which pushed the ice sheet into the spillway pipe. This broke the concrete cap surrounding the pipe which lead to the pipe failure (bending and unraveling). The ice damage reduces the potential water storage in the pond by 3.0 - 4.0 vertical feet.

Picture 1 – A) closeup view of damaged spillway looking north; B) looking northeast; C) short-term fix with sandbags to reduce water loss.

Hire contractor to 1) excavate approximately 4 feet vertical feet of soil to expose existing damaged spillway pipe; 2) cut off damaged section of pipe; 3) add collar and vertical pipe to elevation of prior structure, or replace entire section of existing vertical pipe; 4) replace fill around vertical pipe; 5) form and pour concrete pad (minimum size 8' X 8' by 14" thick); 6) install trash rack; and 7) provide and add rock armoring around cured concrete pad. See Picture 3 for potential example of a spill way tube design and trash rack that is recommended for this project.

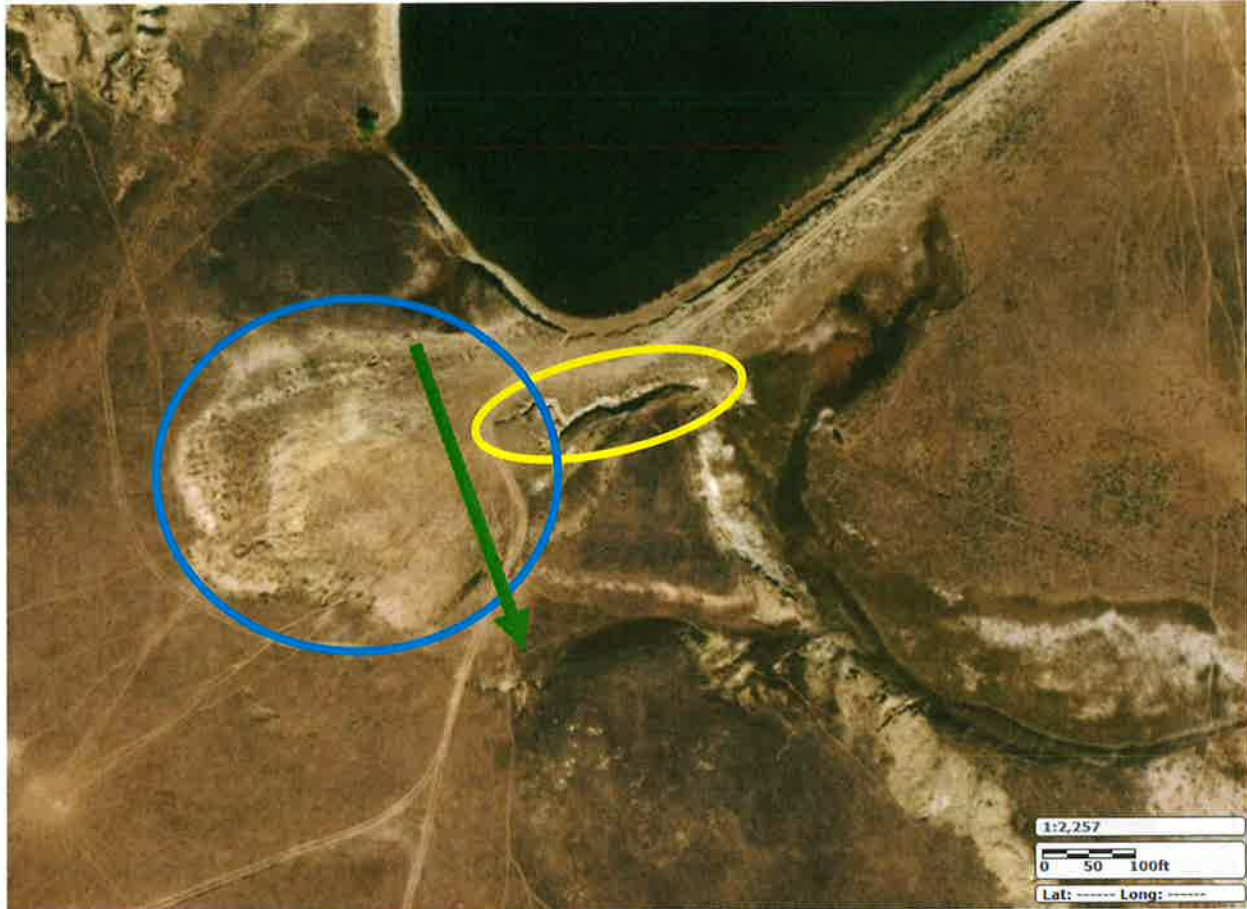
Figure 4 Head cut adjacent to dam (yellow circle), borrow area which is source of run off water (blue circle), and potetial dike location and cut in saddle to reroute run off water (green arrow).

Hire contractor to 1) fill existing head cut; 2) re-slope area uphill of cut to drain runoff through downstream draw (cut drain through small saddle, install dike to route runoff to downstream draw). See figure 4 for details of head cut area.

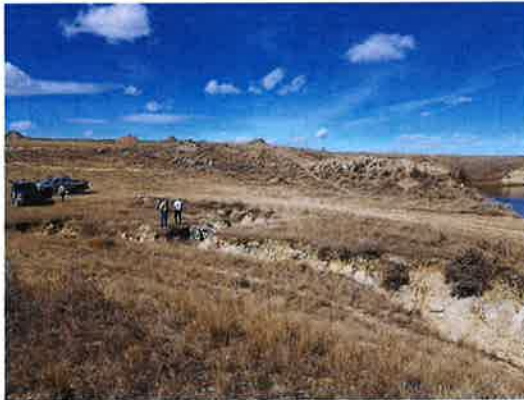
Picture 2 View of head cut looking northwest.
